## Worker falls from ladder when gutter hits high-voltage line

### Notice of Incident information

Number: 2006114550142

Core activity: Gutter installation

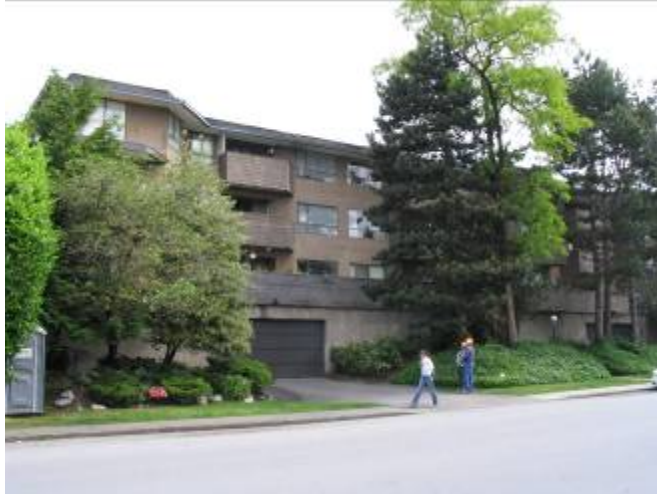
*Figure 1: South side (front) of building.*

The ground sloped away slightly from the building on the south side, which meant that the distance from the ground to the roof was greater on the south side than on the north side. The entrance to the underground parking garage was located on the building's south side.

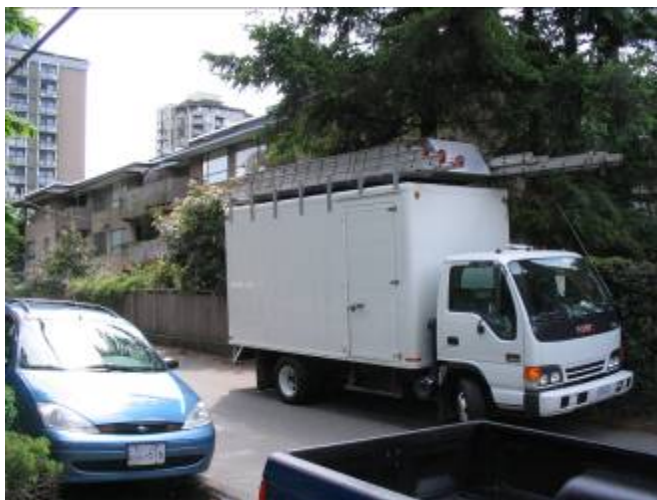
Low-voltage power lines entered the building at the north end, or rear, of the building. These wires were yellow and highly visible.

*Figure 2: North side (rear) of apartment building and truck location.*

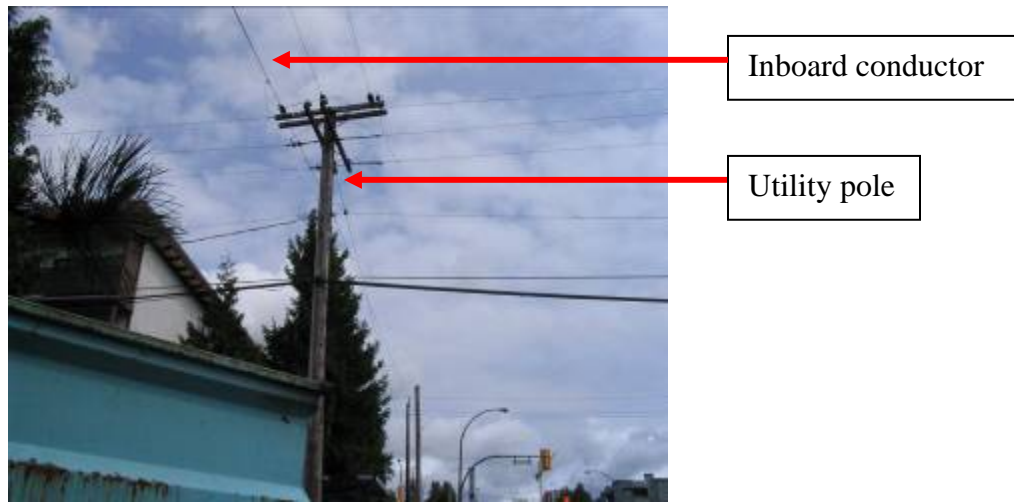
A utility pole carrying high-voltage power lines was located northeast of the building. A 12-kilovolt (kV) circuit supplying electricity to the area consisted of three energized conductors and one neutral line. An inboard conductor (7.2 kV) that was part of the high-voltage circuit was located about 20 feet away from the edge of the building's roof (see Figure 3).

*Figure 3: High-voltage power lines located northeast of the building.*

The employer did not discuss the high-voltage power lines at the pre-job meeting because the lines had not been identified as a hazard. As a result, the workers allowed the gutter to come within the limits of approach. The gutters should have been kept a minimum distance of 3 metres (10 feet) from the power lines, according to [section 19.24](#) of the Occupational Health and Safety Regulation.

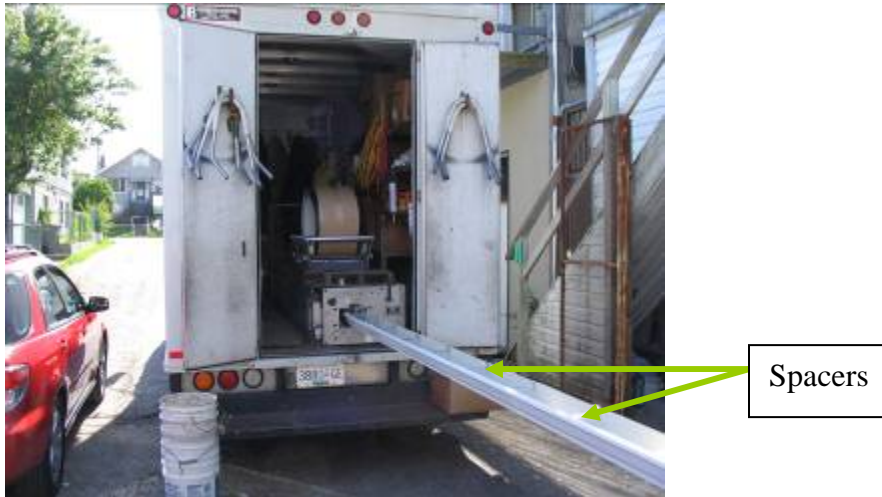
Gutters are usually cut to measure on the job site. A gutter-forming machine is transported in a truck. A spool of aluminum is fed into the machine, which shapes the aluminum into gutters. The gutters are then cut to the desired length. Spacers are inserted to maintain the gutter profile (see Figure 4).

**Figure 4:** Gutter fabrication machine in rear of the employer's truck.

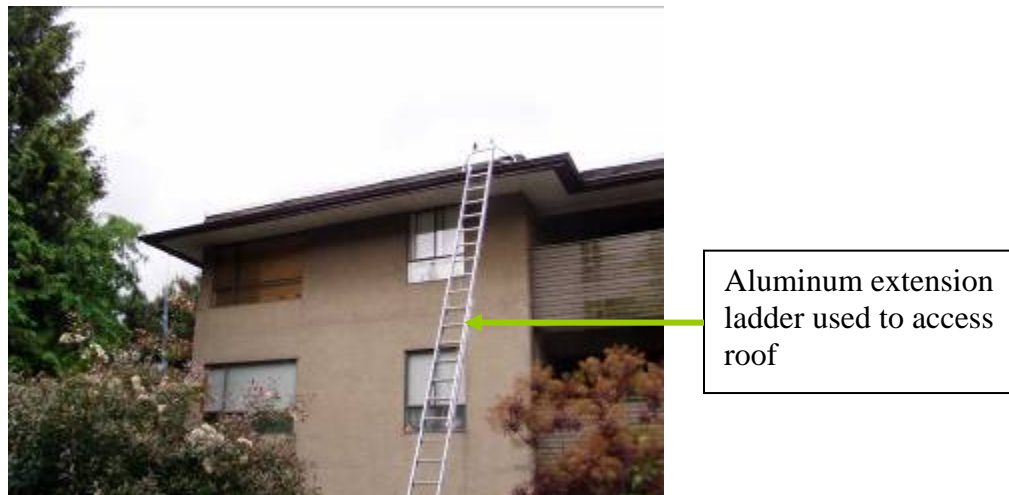
The crew parked the gutter truck in the lane behind (on the north side of) the building and set up an aluminum extension ladder on the northeast end of the building (see Figure 5). Worker 1 and Worker 2 climbed up onto the roof. They measured the required lengths of gutter and called the lengths down to Worker 3, who made the gutters to length in the truck on the ground. Worker 3 passed the finished gutter sections up the extension ladder to Worker 1 and Worker 2 on the roof, who then installed the gutters.

**Figure 5:** Ladder on north side of building. The low-voltage lines are not visible in this photograph but are located 25 feet to the right of the ladder.

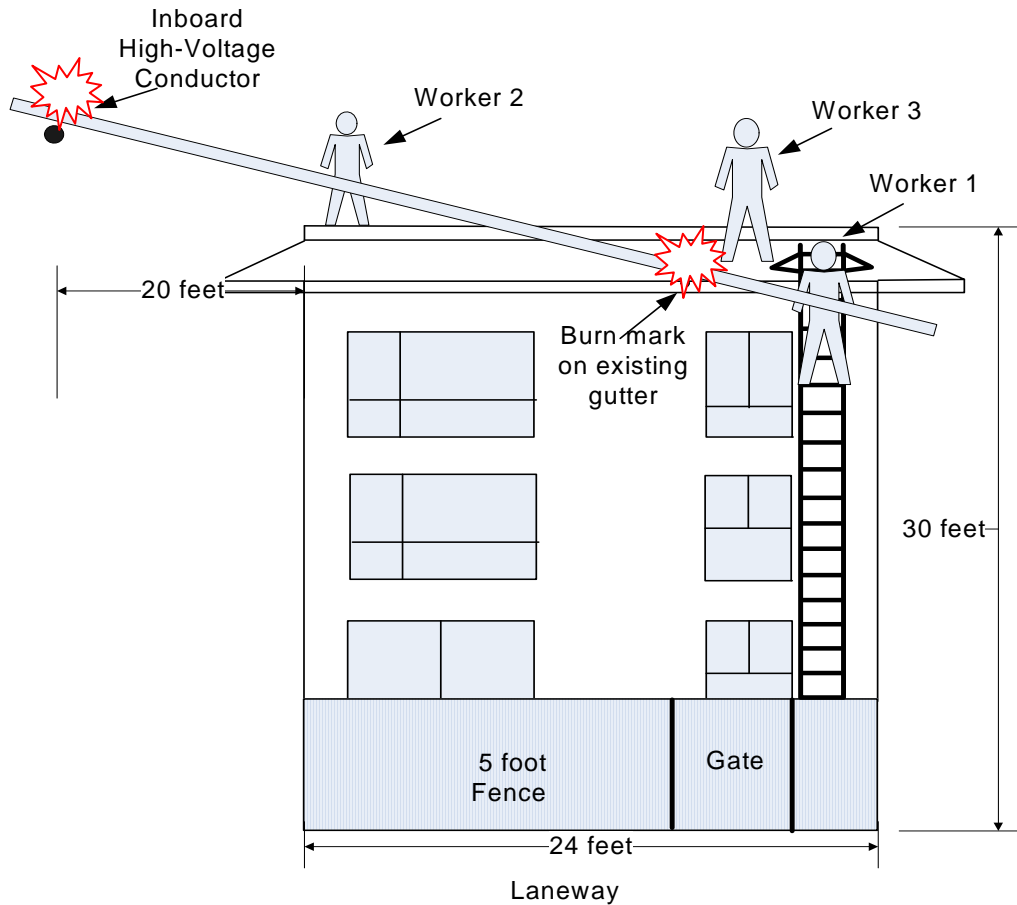
the north side of the roof. The top end of the gutter now protruded 20 feet beyond the edge of the roof and rose above the high-voltage power lines. As Worker 1 lifted the lower end of the gutter, the top end began to come down and contacted the inboard conductor, which was attached to the utility pole located near the building (see Figure 6).

**Figure 6:** Positions of workers, gutter, and high-voltage power lines.

When the gutter contacted the power line, Worker 2, who was standing on the flat roof and positioned closest to the high-voltage line, was still holding the gutter. He felt nothing but heard a loud bang and saw a flash of light beside Worker 1. Worker 3 heard a bang and also saw a flash of light where the lower end of the gutter contacted the existing gutter. Almost instantly Worker 1 let go of the lower end of the gutter and fell backwards off the ladder 22 feet onto the concrete patio.

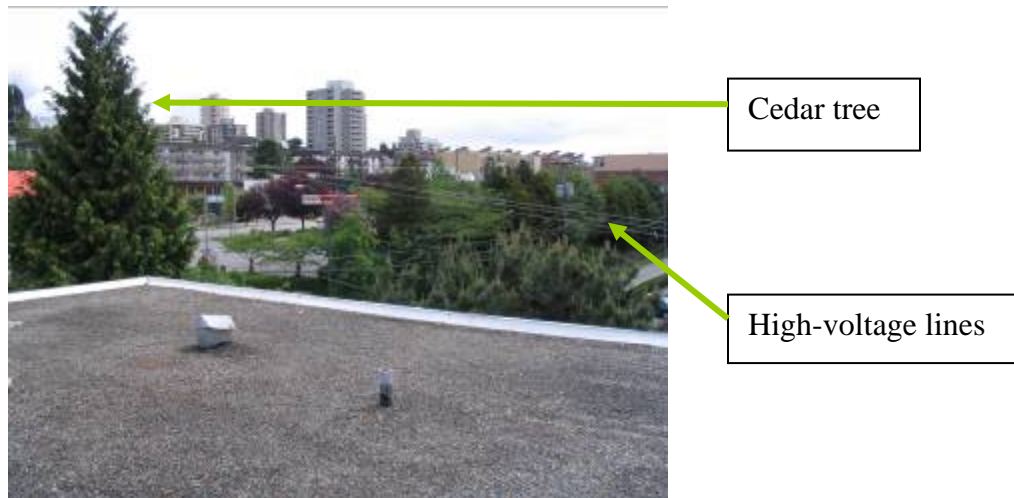
From the point of view of someone standing on the roof and looking northeast, a large cedar tree obscures the utility pole (see Figure 7). The grey high-voltage lines run parallel to the roof of the

building and blend into the background. This would especially be true on an overcast day like the day of the incident.

*Figure 7: View of power lines from the roof of the building, looking northeast.*

One expects high-voltage lines to be connected to a utility pole, yet the closest utility pole for the high-voltage lines was concealed by a large tree (see Figure 7). A solid object, such as a utility pole, is easier to see than a thin object, such as an electric wire. Without the visual connection of the lines to the pole, the lines appeared out of their expected context. This would decrease the likelihood of the workers noticing the lines.

Contrast—which is the difference in brightness, colour, or texture between an object and its background—affects the visibility of objects. The grey high-voltage lines, viewed against the grey sky, produced limited contrast, making them difficult to see. Grey high-voltage lines do not emphasize their importance and hazardous nature.

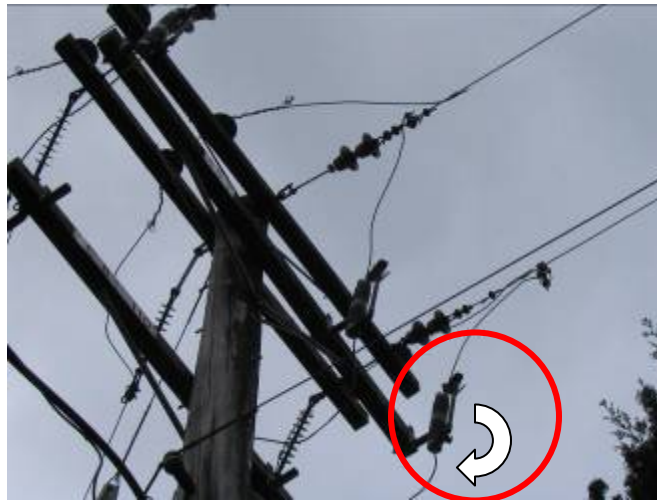
When the gutter contacted the conductor, a 100-amp fuse tripped, resulting in a loud bang. The fuse arm (see red circle in Figure 8) released and swung down, causing a power outage in the area.

*Figure 8: 100-amp fuse.*
